West Coast Home Inspections

CONFIDENTIAL INSPECTION REPORT

THIS IS A PARTIAL REPORT ONLY, any where usa,

12/25/2005 10:00 am to 12:00 pm

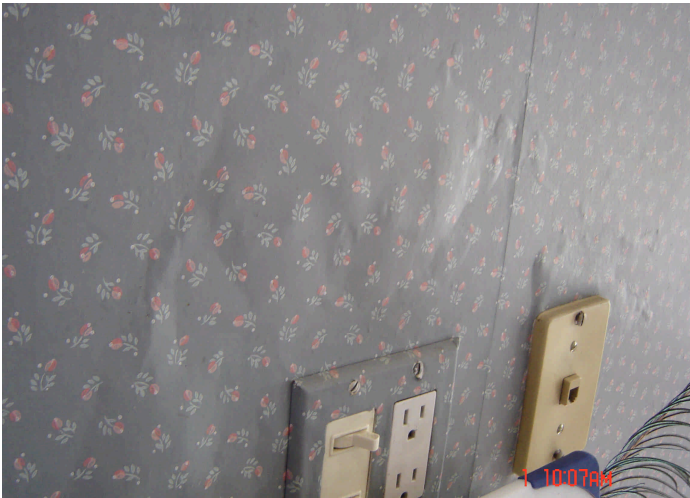
There is evidence of moisture intrusion within the residence that we will point out, which should be remediated by a licensed specialist. However, you should also be aware that where moisture goes mold usually follows.

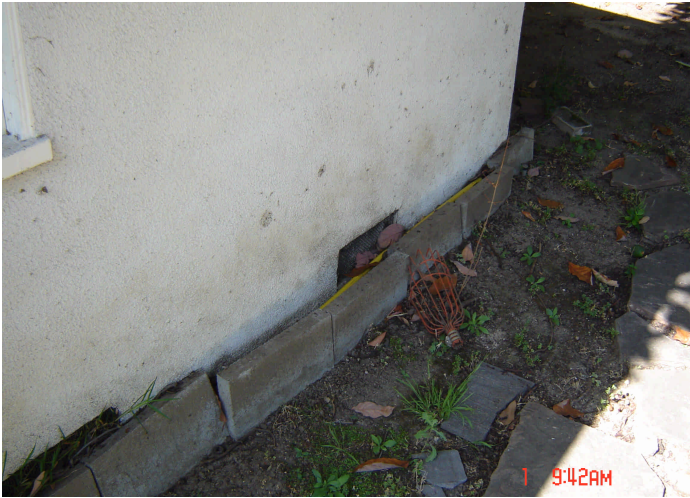
Grading and drainage is either negative or neutral adjacent to the residence, and moisture intrusion will remain a possibility. The soil or the hard surfaces should slope away from the residence to a distance of at least six feet, to keep moisture away from the footings. We can elaborate on this issue, but you should seek a second opinion from a geologist or grading and drainage contractor.

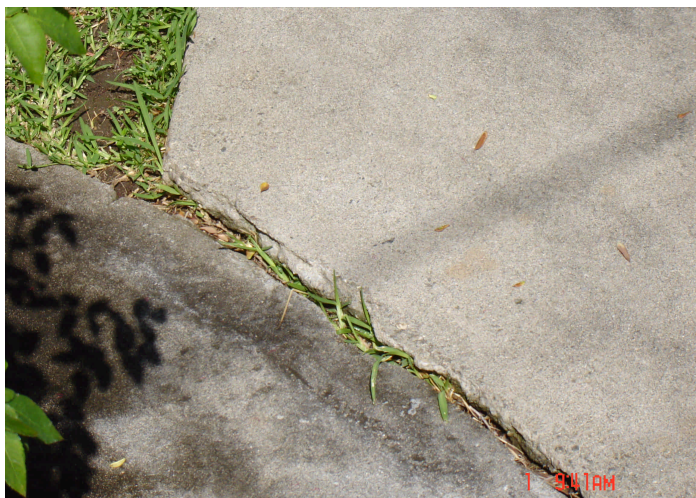
There are several offsets in the walkways that could prove to be trip-hazards.

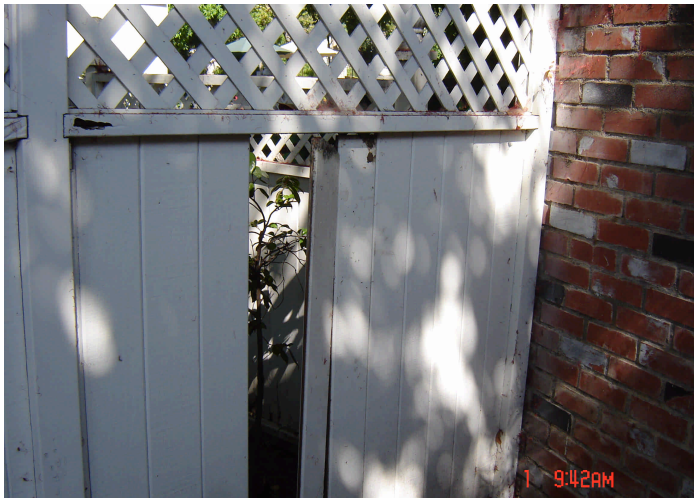
Portions of the fences or gates are dry rot or termite damaged, which should be evaluated by a termite inspector. However, you may wish to confirm that fences and gates are included in the termite inspection.

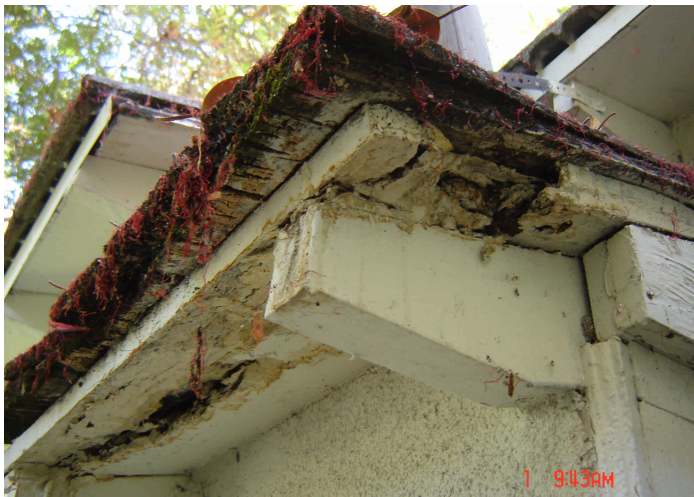
The fascia board and trim, and particularly that on the south facing side that is exposed to the sun, are in poor condition and should be serviced.

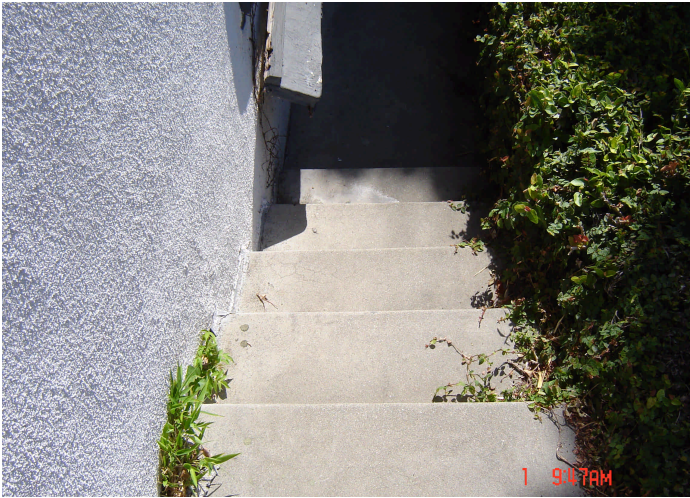
As a safety precaution, we recommend installing handrails on steps that have three or more risers, and particularly if children or the elderly visit or occupy the property.

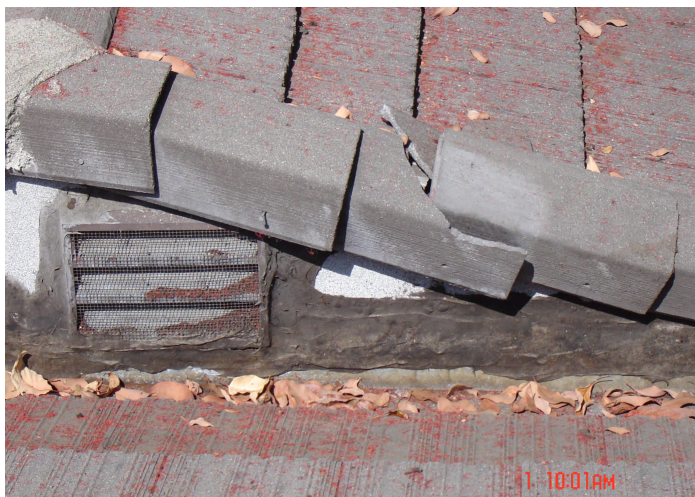
There are a number of cracked or broken tiles that should be serviced.

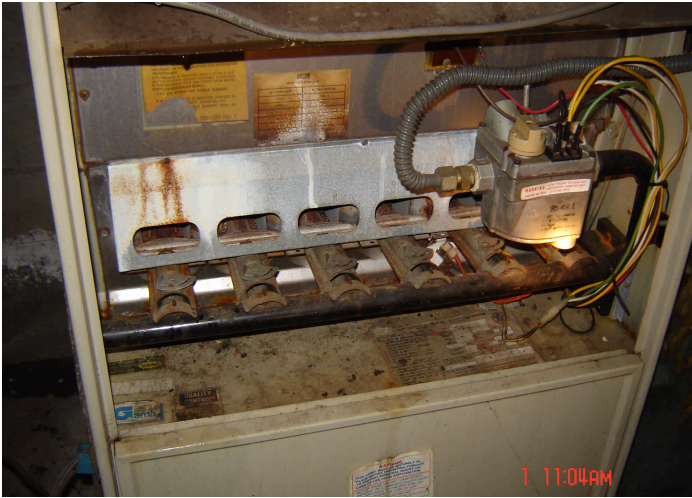
Rust particulates are accumulating below the burners in the combustion chamber of the gas furnace. They are typically caused by condensation, but should be removed before more particulates gather and smother the burners. We suggest a complete evaluation by a state licenced hvac contractor

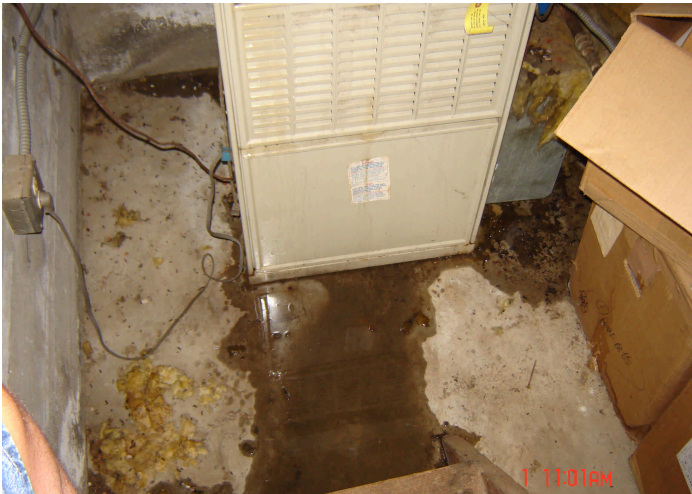
The condensate pipe is missing and should be extended to discharge outside the residence.
